Status of Small-Scale Irrigation Projects in Amhara Region, Ethiopia

Bitew Genet Tassew¹

Abstract

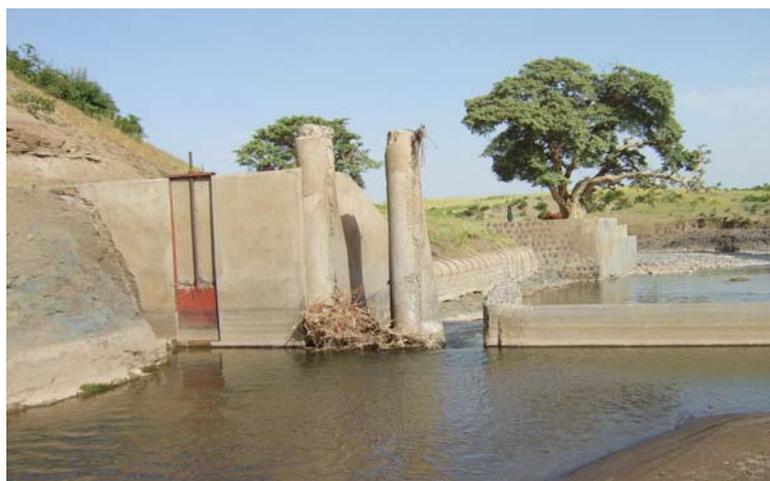
Figure 3: Part of Gray River Diversion

The water level upstream of a structure is higher than the downstream water level. Therefore water may search for another way underneath or along the structure, or even through a crack in the bottom or sides of the structure to this lower level. The Figure 3 below shows part of the diversion weir collapsed due to scouring and Figure 4 shows the leakage on headwork of Geray irrigation project and result in water loss and forced the weir to damage.

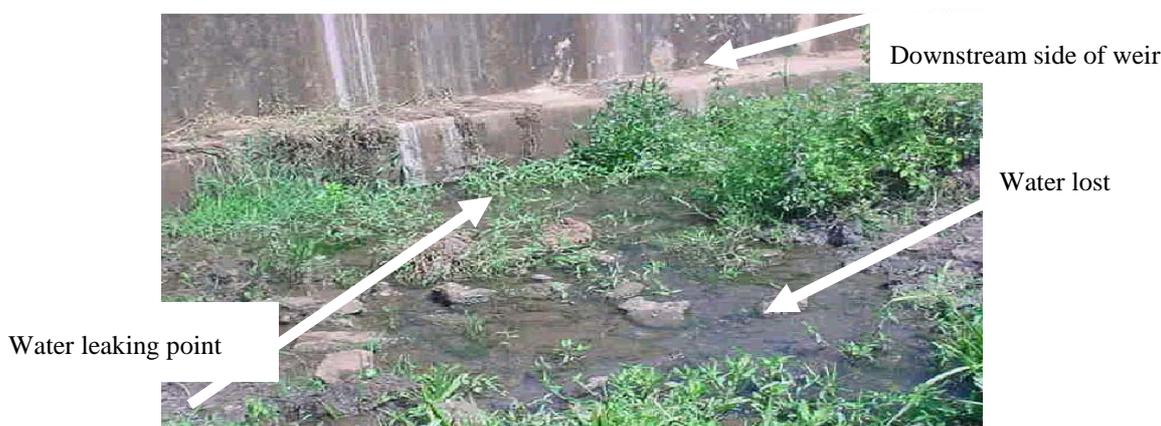
Figure 4: Leakage on Geray River Diversion

- IV. Water losses and leakages in Geray and Adrako headworks and canals of Tebi and Kility caused by holes in embankments of canals often due to improper compactions or organic material buried in bunds, crabs and other digging animals, small embankment of canals and leaking lining. Figure 4 shows this problem.

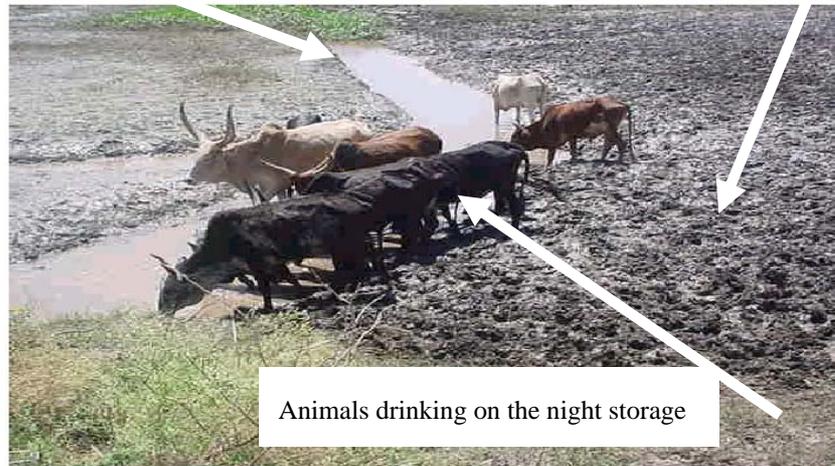
Figure 5: Night Storage of Gulina Irrigation Scheme

The deposition of soil and debris can affect the functioning of a structure. If for instance, a stilling basin collects soil deposits the available water mass diminishes and energy dissipation will be less effective. Similarly, in the case of soil deposits in a flow division box, the division of the flow will be less accurate due to imbalance in flow velocities and water levels. The same applies for intake structures and night storages, such as the pumping stations. Large volumes of sand in the intake

chamber of the pumps causes damage to the pumps and will lead to sand deposits in the canal system too. Figure 5 shows night storage of Gulina irrigation scheme, which is silted up by sediments and misused as trough for drinking animals.

Water storage surface (Reservoir)

Sediment accumulation

- Measures for sediment flushing should be considered to prolong the life of the reservoirs and preserve a long-term useful storage capacity.
- Installing bottom outlets for sediment discharge by considering the amount of sediment entering the reservoir.
- To accommodate more silt deposition increasing dam height is also an alternative.

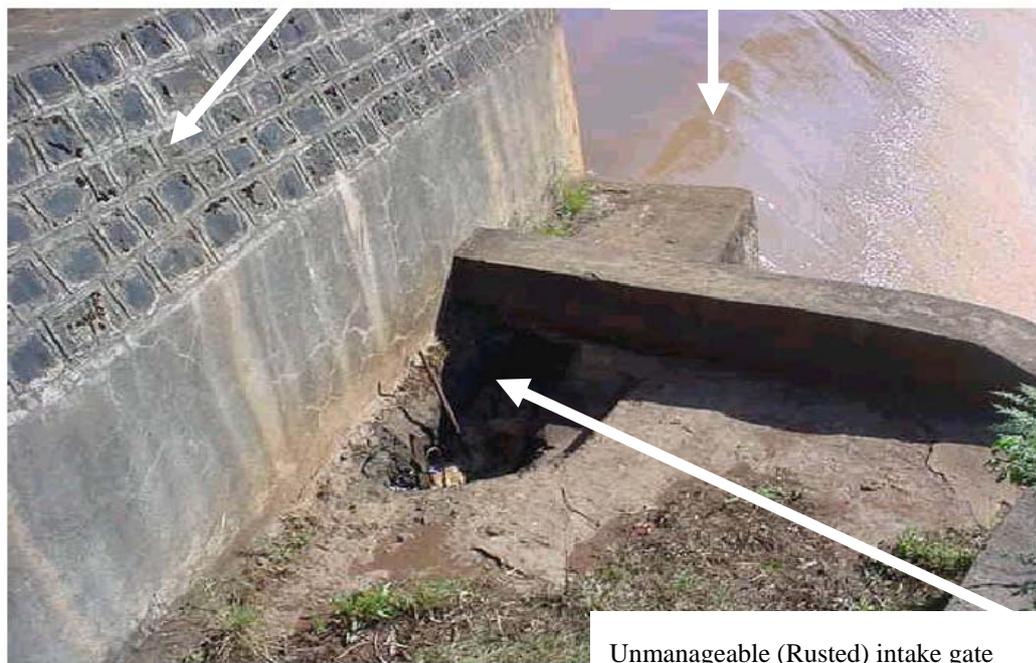
Figure 6: An intake gate of Fetam Diversion

Wooden and steel parts in structures suffer from being alternately wet and dry. The wooden parts will rot and disintegrate, while steel parts will rust, expand and get jammed in the slides. All such corrosion affects in a negative way the operation of the structures. Routine maintenance is necessary to avoid these problems, or to reduce their effect to a minimum. Figure 6 shows an intake gate of Fetam diversion, which is deteriorated due to rust and is not manageable to operate.

Diversion weir

Overflow spillway
